# INTERNATIONAL JOURNAL OF ENGINEERING SCIENCES & MANAGEMENT

## DESIGN OF WIND TURBINE BLADE BY COMPOSITE MATERIAL

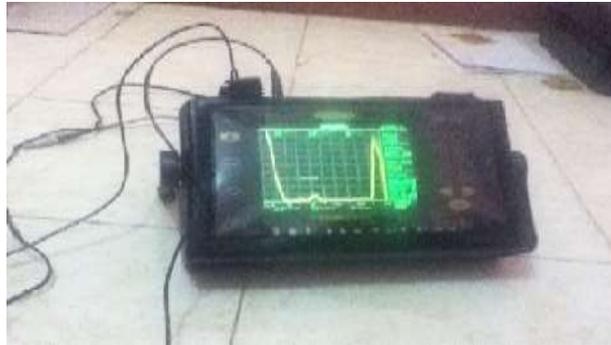
**Fig.1 ultrasonic test result for E-glass fiber/epoxy resin specimen**

incidence in pulse-echo mode. By using initial echo and Back wall echo the specimen thickness is placed and the intermediate echo points are studied in the defect identification two different specimens are examined for the ultrasound and the test results are recorded in the fig. 1&2. The intermediate echo points are taken as the defect portion. The measurements have been executed at normal incidence in pulse-echo mode. Every bit a first approach, initial measurements with both transducers have been performed and compared. A higher frequency wave is desirable to make the smaller divergence angle and higher sensitivity and in-depth resolution. On the other hand, due to the intrinsic density-inhomogeneities of composite materials, the scattering that undergoes the acoustic wave is relatively high.

- In the X-ray CT technique depending is noted in E-glass/epoxy resin and delamination is noted in E-glass/vinylester resin.
- The ultrasonic test report shows that E-glass fiber/epoxy resin is better than that of the E-glass fiber/vinylester resin by comparing the defects

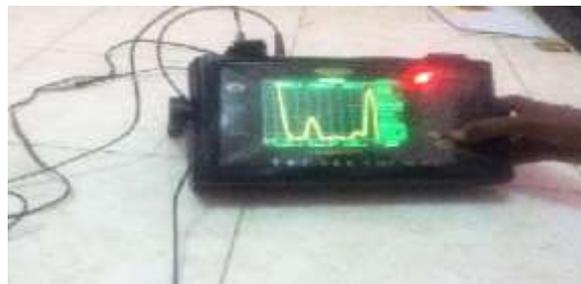
**Fig.2 ultrasonic test result for E-glass fiber/vinylester specimen**
